RE: NOTICE OF VIOLATION Facility # 69516  
455B.186 Prohibited actions  
567 IAC 61.3(2) General Water Quality Criteria  
567 IAC 121.4(1) Land Application of Solid Wastes  
567 IAC 65.2 Minimum Manure Control Requirements and Reporting of Releases

IOWA DEPARTMENT OF NATURAL RESOURCES  
AFO INSPECTION REPORT

Justin Harbaugh Feedlot Map  
26825 Ironwood Road, Elkader, Iowa Facility #69516

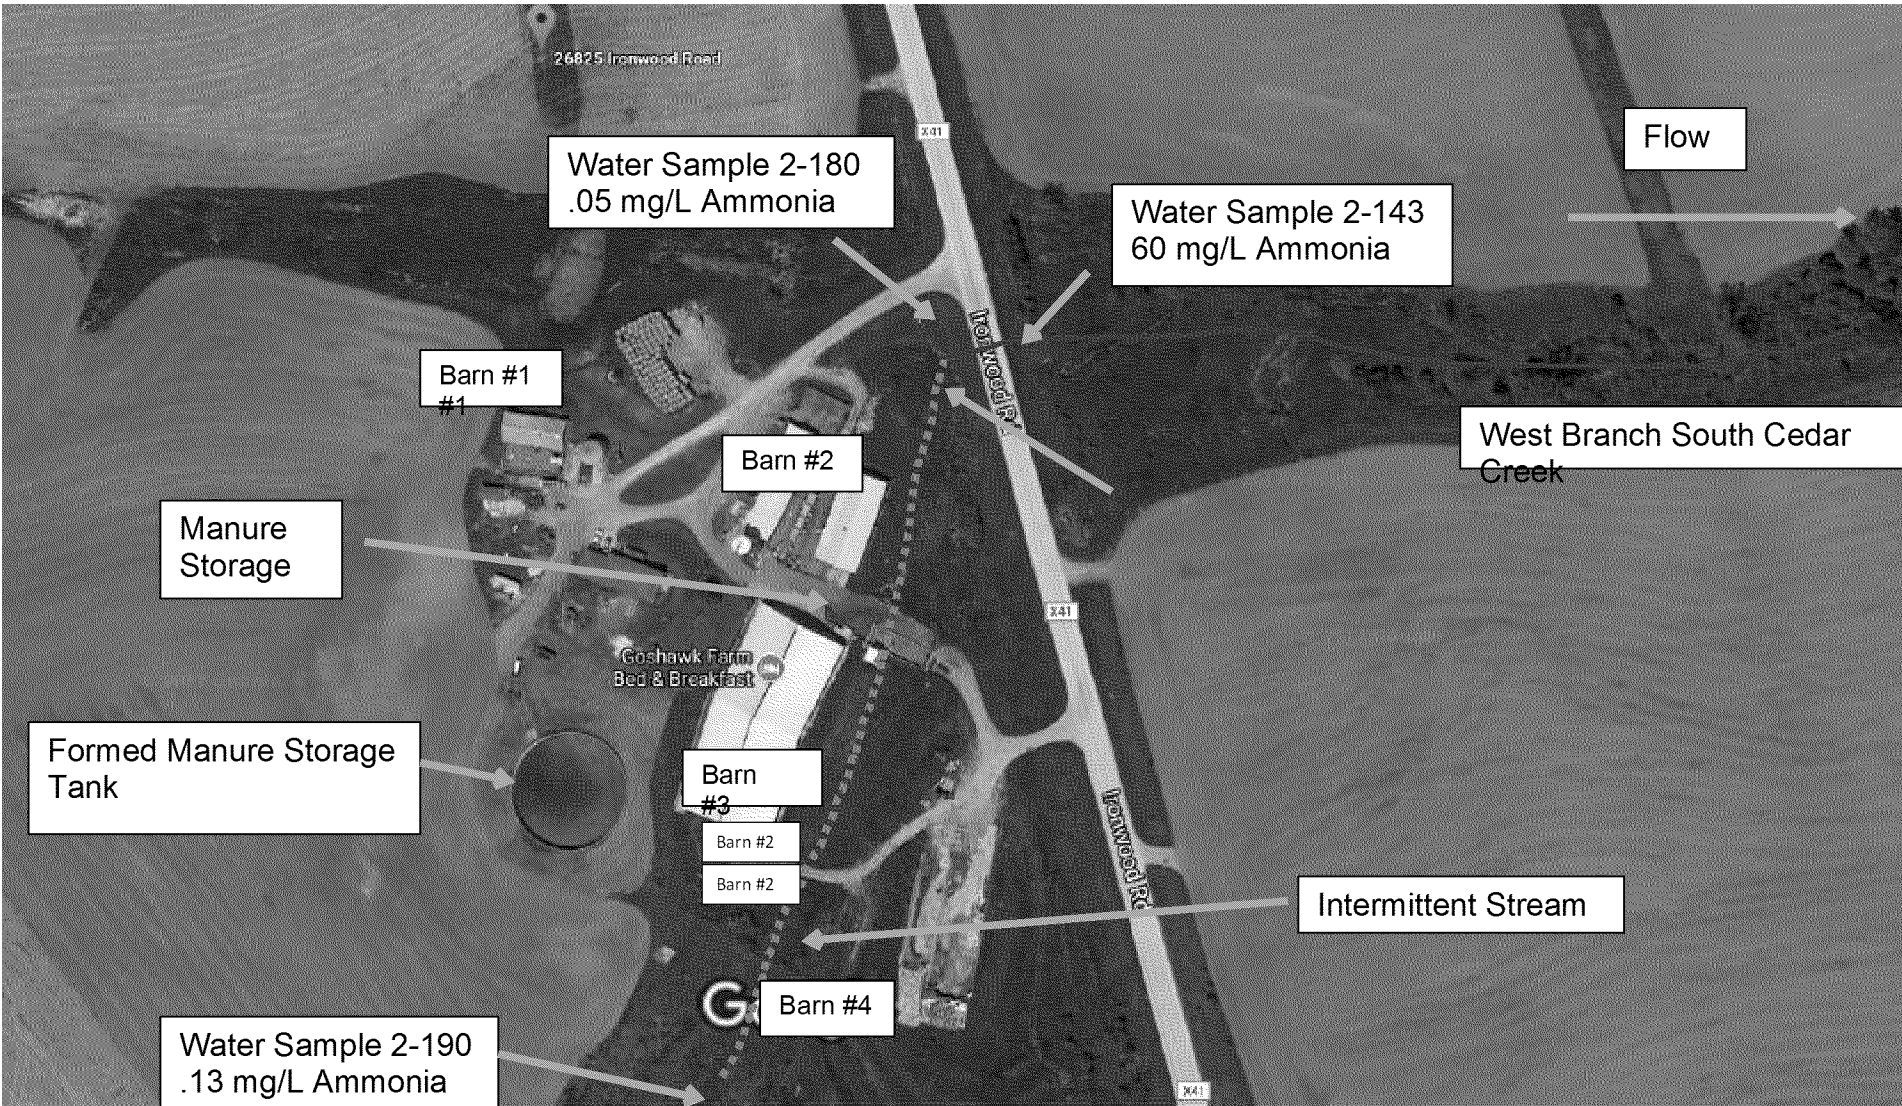
On August 9<sup>th</sup>, I returned to the site and met with Mr. Harbaugh. We were later met by Brian Jergenson, Environmental Specialist Senior, Field Office 1. We jointly inspected the animal feeding operation and Mr. Harbaugh provided a description (see Map).

The "upper shed" is barn #1 and currently houses 34 feeder cattle. It is partially roofed and an open feedlot. No evidence of manure discharge was observed. Barn #2 is the former milking barn and had 150 head of cattle. There are two roofed buildings that share an unroofed center pen. This open feedlot is scraped into the manure storage structure between Barn #2 and Barn #3. Barn #3, a converted free-stall barn is totally roofed, held 188 head of feeder cattle and is a confinement barn. Barn #4 is a converted feed storage bunker and 188 head of cattle occupied this partially roofed structure, considered an open lot.

Mr. Harbaugh explained that all manure is in a solid form. Pens are bedded every two weeks and scraped approximately every three weeks. Manure is contained in solid form in the unroofed formed storage structure between buildings #2 and #3. All animal feeds are under roof. Gutters were added to Barns #2 & #3 and rain water is diverted around the barns, pens and manure holding structure. The facility does not utilize a manure management plan and has 180 acres of crop fields for manure application.

We observed the 1.4 million gallon formed storage tank. Mr. Harbaugh stated that it was last emptied in the fall of 2013 and currently has a freeboard of 22 inches. He described the contents as water, whey, waste milk and manure. He also stated that 5,000 gallons of antibiotic contaminated milk was rejected by Swill Valley and placed in the tank about a week prior. Mr. Harbaugh noted that liquids from the tank are disposed as needed by spray irrigation to the six acre vegetated application area.
